City of Alexandria Storm Sewer Capacity Analysis (CASSCA)

Strawberry Run Condition Assessment

PREPARED FOR: City of Alexandria, CH2M Hill
PREPARED BY: Michael Baker Jr., Inc.
DATE: February 14, 2014 (Revised May 26, 2015)

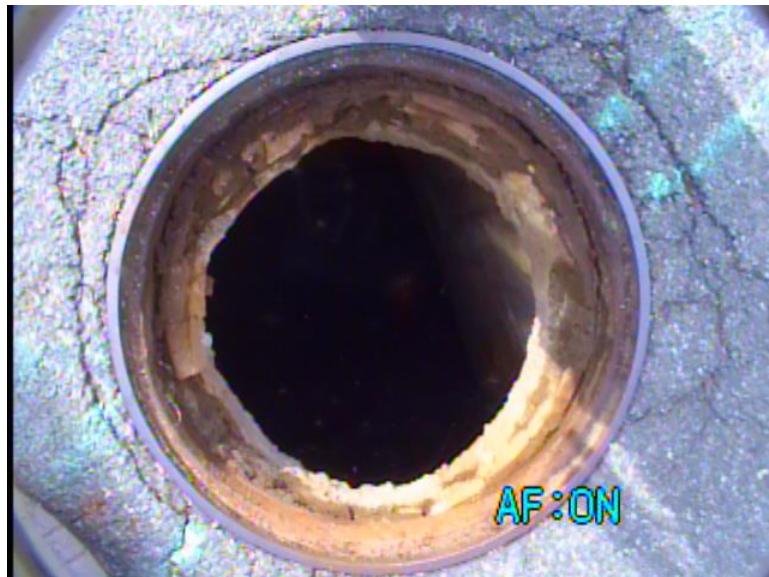
Examples of problems in the moderate category for the frame base seal, and chamber are shown in Figures 4 and 5, respectively.

**Figure 4. Moderate Frame Base Seal Damage on Structure 000413SMH
(Overall SCREAM Score = 61).**

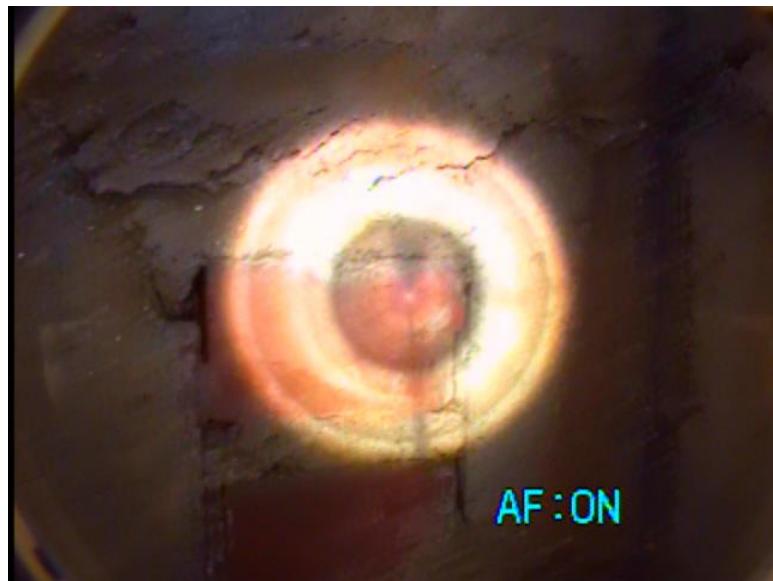
**Figure 5. Moderate Chamber Wall Damage on Structure 000612SMH
(Overall SCREAM Score = 60).**

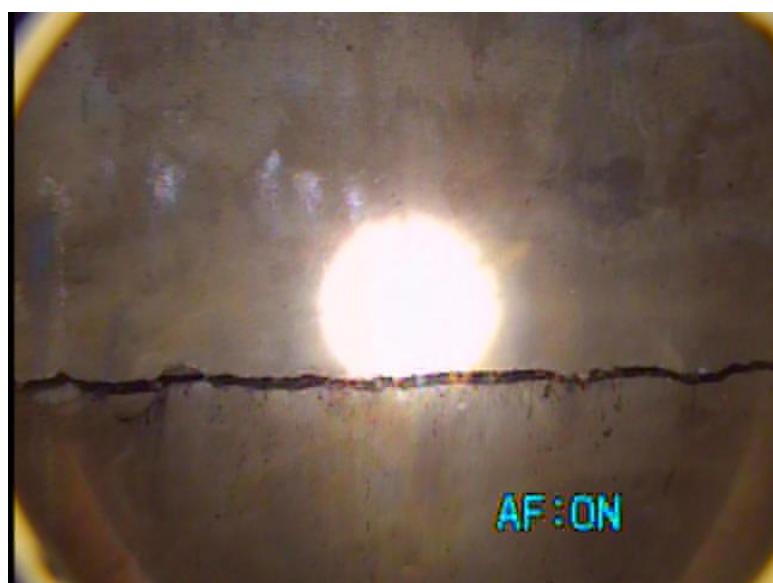
The problems in the major category were most frequently associated with the chamber areas. Cracks in the chamber between 1/8" to 1/4" in width, for example, are considered major damage. Settled debris in the manhole also contributes to the overall score; 3-5 gallons of debris present in the channel ranks in the major range of defects. Figures 6 and 7 are examples of major damage to the chamber wall and manhole channel.

**Figure 6. Major Damage to Chamber Wall in Structure 001342IN
(Overall SCREAM Score = 56).**

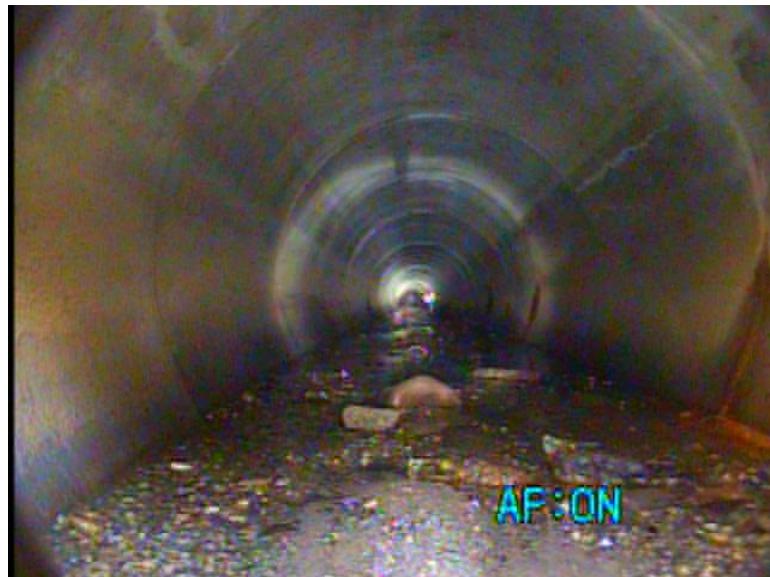
**Figure 7. Major Channel Debris in Structure 000616SMH
(Overall SCREAM Score = 57).**

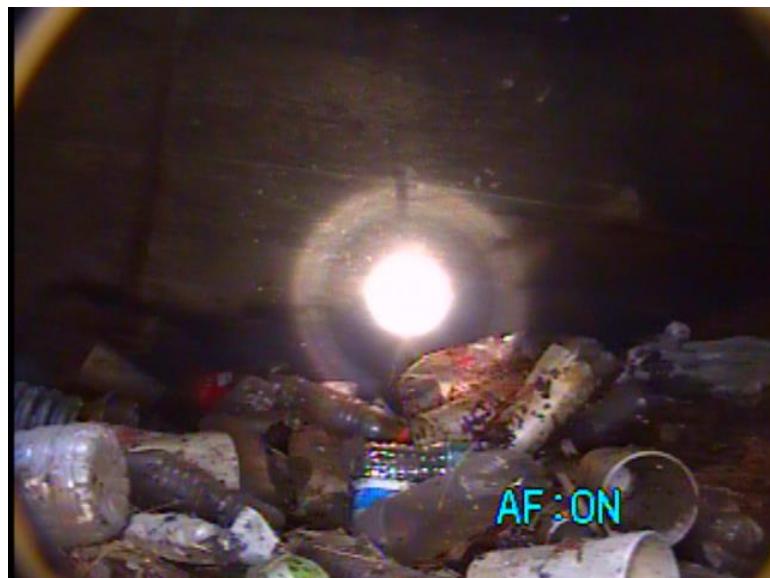
The problems in the component extreme category were associated with the manhole channel (3 instances) and pipe connections (2 instances). Generally, this involved either large amounts of settled debris (more than about five gallons), large cracks in the concrete (larger than $\frac{1}{4}$ inch), or spalling and etching (25% to 50% material loss). Infiltration associated with the cracks (inflow higher than about 10 gpm) is also ranked in the extreme category of defects. Figures 8 and 9 are examples of problems in the extreme category in manhole channels; figures 10 and 11 are problems associated with the manhole pipe connections.

**Figure 8. Heavy Debris in Structure 000609SMH
(Overall SCREAM Score = 67).**

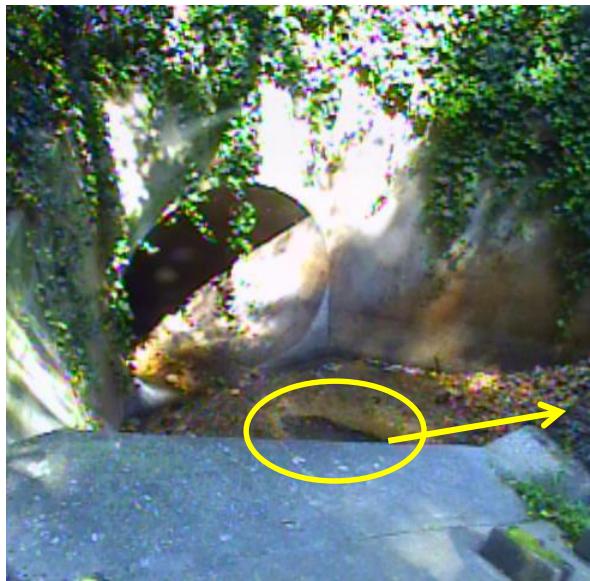
**Figure 9. Channel Damage at Structure 000118IO
(Overall SCREAM Score = 39).**

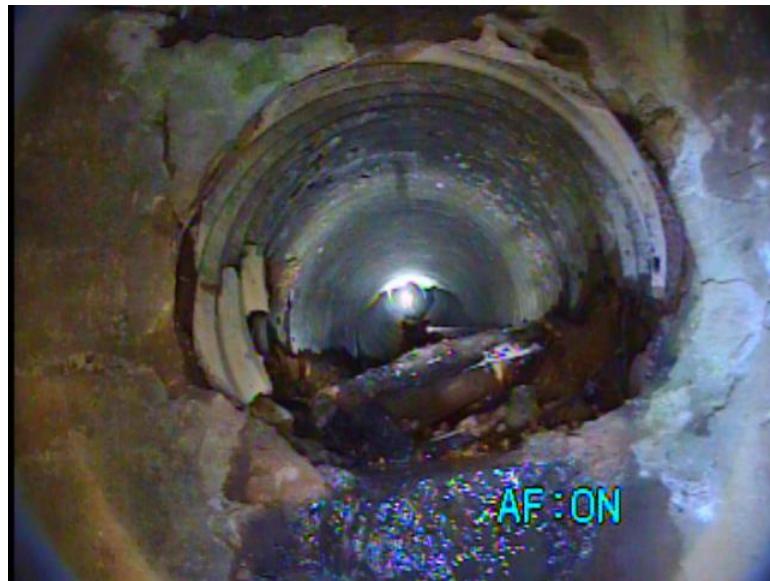
**Figure 10. Damaged Pipe Connection in Structure 002870IN
(Overall SCREAM Score = 69).**

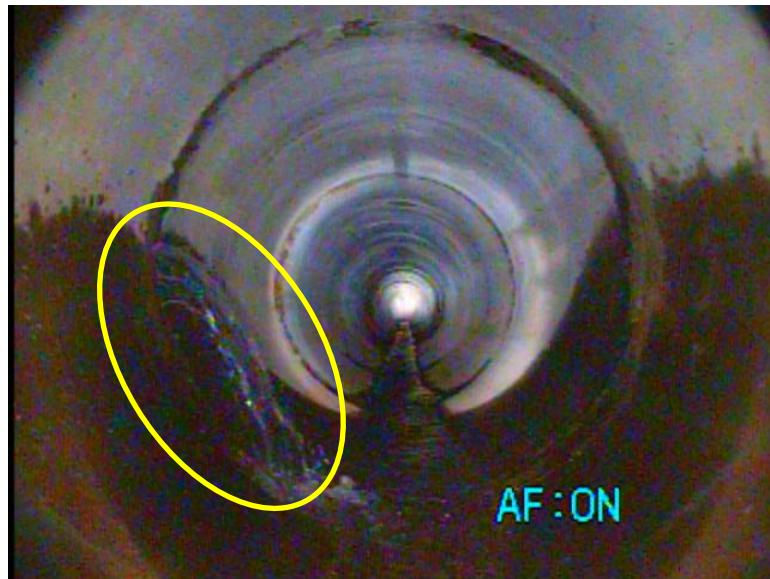
The highest total structure score in Strawberry Run was 76 (pictured in Figure 10). Therefore, no single structure had enough defects to rank in the overall “Extreme” category.

**Figure 11. Infiltration at Pipe Connection in Structure 002875IN
(Overall SCREAM Score = 76).**

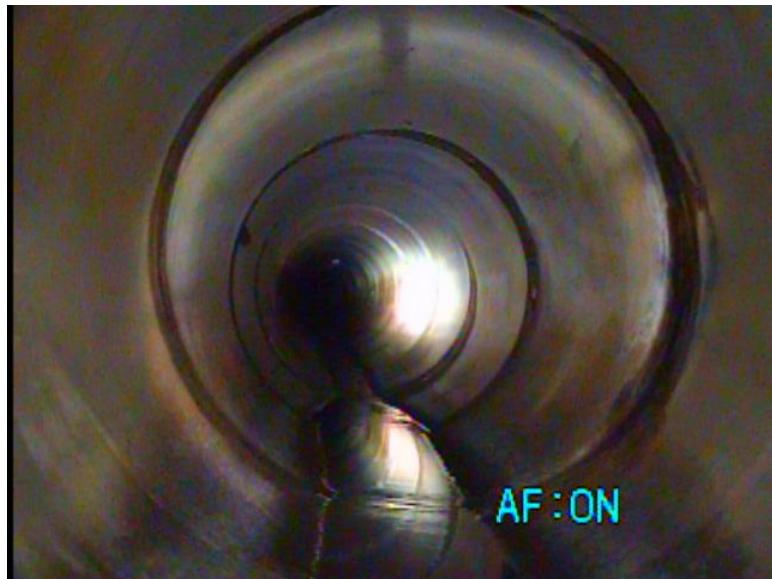
The following images captured during the lamping inspections show typical defects observed within Strawberry Run storm pipes. Figure 14 shows evidence of low levels of infiltration (less than 1 gpm) inside a 36-inch pipe. This segment has an overall SCREAM score of 7 (Few defect category), indicating relatively low level of damage. Figure 15 is an example of multiple longitudinal cracks and slightly higher levels of infiltration (between 1 and 3 gpm); this 42-inch diameter segment has an overall SCREAM score of 32 (Minimum). The 36-inch storm pipe in Figure 16 has an overall SCREAM score of 47 (Moderate), due to settled debris and an offset joint of 2-3 inches. Figure 17 is a photograph of a broken 21-inch pipe with an overall SCREAM score of 60 (Moderate), the highest in Strawberry Run. Note that the photograph of the damaged pipe connection in Figure 10 corresponds to the broken pipe in Figure 17.

**Figure 14. Low Infiltration in 36-in Storm Pipe between Structures 000891SMH and 002870IN
(Overall SCREAM Score = 7).**

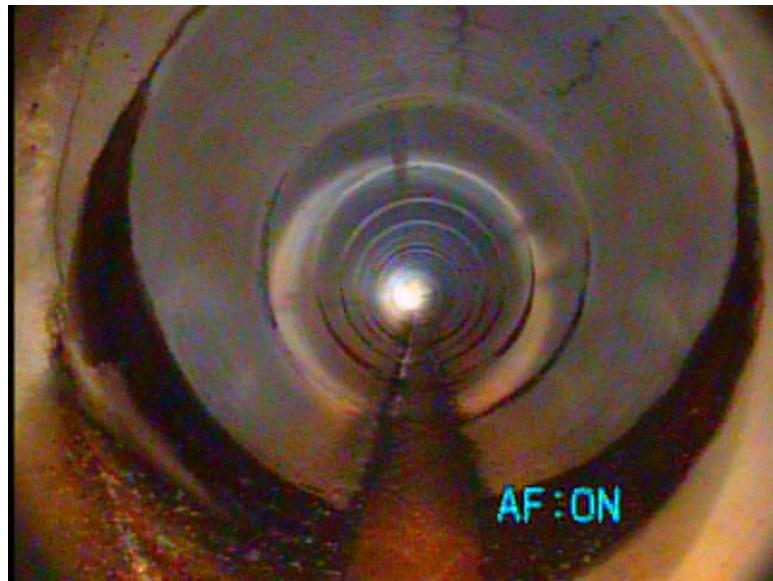
**Figure 15. Multiple Cracks & Infiltration in 42-in Storm Pipe between Structures 001285IN and 001282IN
(Overall SCREAM Score = 32).**

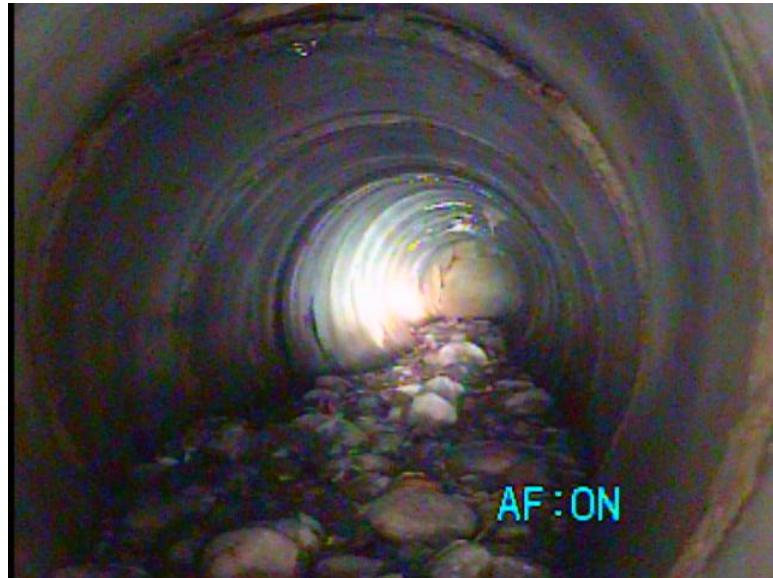
**Figure 16. Settled Debris and Displaced Joint in 36-in Storm Pipe between Structures 000885SMH and 000887SMH
(Overall SCREAM Score = 47).**

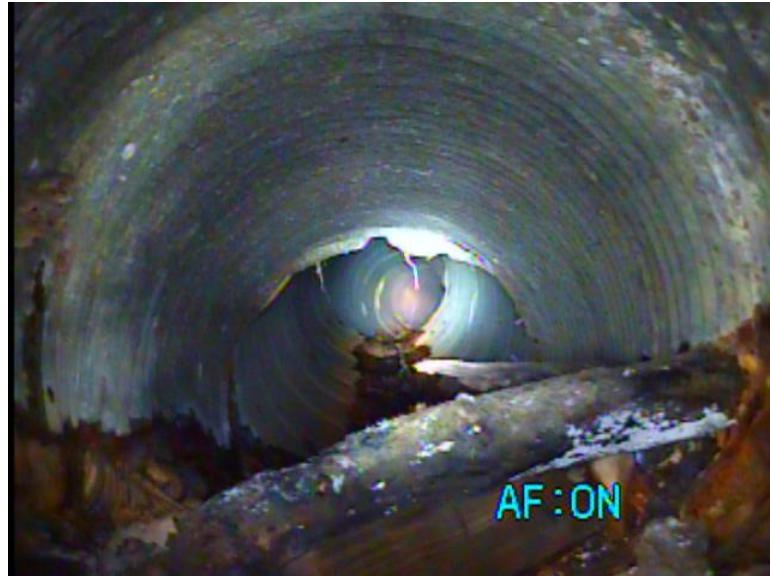
**Figure 17. Broken 21-in Storm Pipe between Structures 002889IN and 002870IN
(Overall SCREAM Score = 60).**
